EXPERIENCE IN THE APPLICATION OF PERMEABLE INTERLOCKING CONCRETE PAVING IN AUSTRALIA

This paper reports assessments of a range of permeable interlocking concrete pavements (PICP) that have been in service around Australia for periods of around 10 years. Each of the assessments is supported by a critical review of the properties and in-service performance of the pavements based on in-situ measurements and inspections, supplemented by laboratory test data. Factors studied include the infiltration rate, structural properties and performance together with lifespan and physical filtration efficiency. The effects of sediment load and pavement clogging have also been examined.

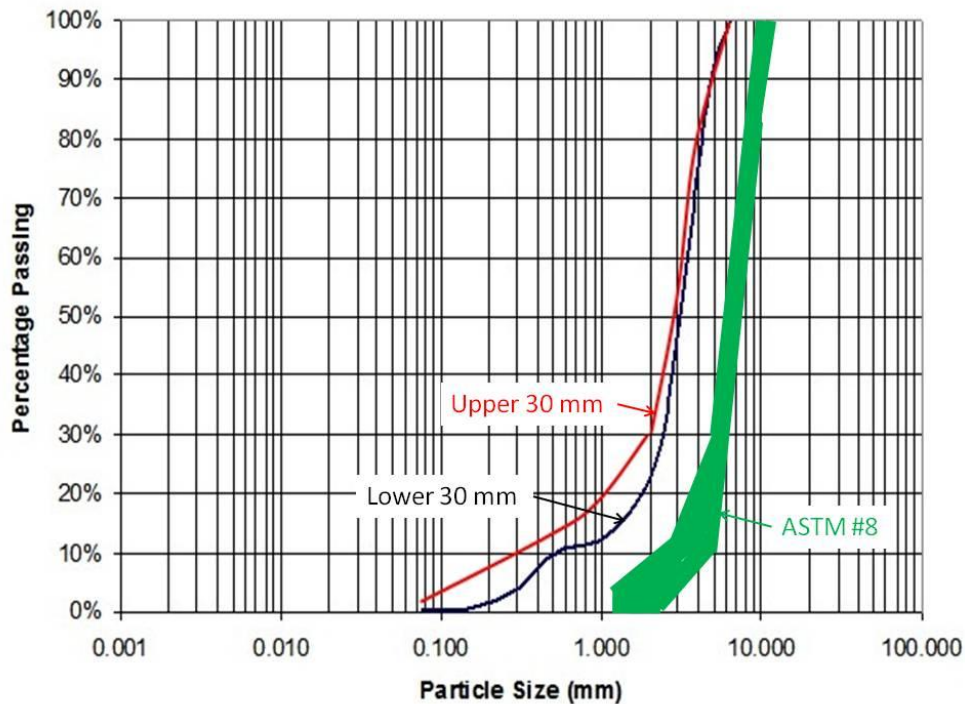
Figure 2. Typical Gradings for Upper and Lower Jointing Material.

At 10 of the 14 locations it was found that there were more fine particles in the upper 30 mm than in the lower 30 mm to 60 mm of jointing material. The results are shown in Figure 2. These indicate that the increase in fines generally occurred in the particle size range of 0.2 mm to 2.0 mm.

Of the samples showing little change in grading between the upper and lower portions of jointing material, one was from an area swept immediately prior to sampling at Smith Street, Manly, while two were from Olympic Park where mechanical sweeping was used routinely. The fourth sample was collected near a tree on the Karrabee Avenue parking area for which the maintenance history is unknown. The jointing material sampled from areas known to have been swept showed no change in fines between the upper (0 mm to 30 mm) and lower jointing depths (30 mm to 60 mm). This indicates that most of the fine clogging materials observed in the upper depths of the joint material for unswept pavements would have been located immediately at the top of the joints, i.e. from where it could easily be removed by sweeping.
