EXPERIENCE IN THE APPLICATION OF PERMEABLE INTERLOCKING CONCRETE PAVING IN AUSTRALIA

This paper reports assessments of a range of permeable interlocking concrete pavements (PICP) that have been in service around Australia for periods of around 10 years. Each of the assessments is supported by a critical review of the properties and in-service performance of the pavements based on in-situ measurements and inspections, supplemented by laboratory test data. Factors studied include the infiltration rate, structural properties and performance together with lifespan and physical filtration efficiency. The effects of sediment load and pavement clogging have also been examined.

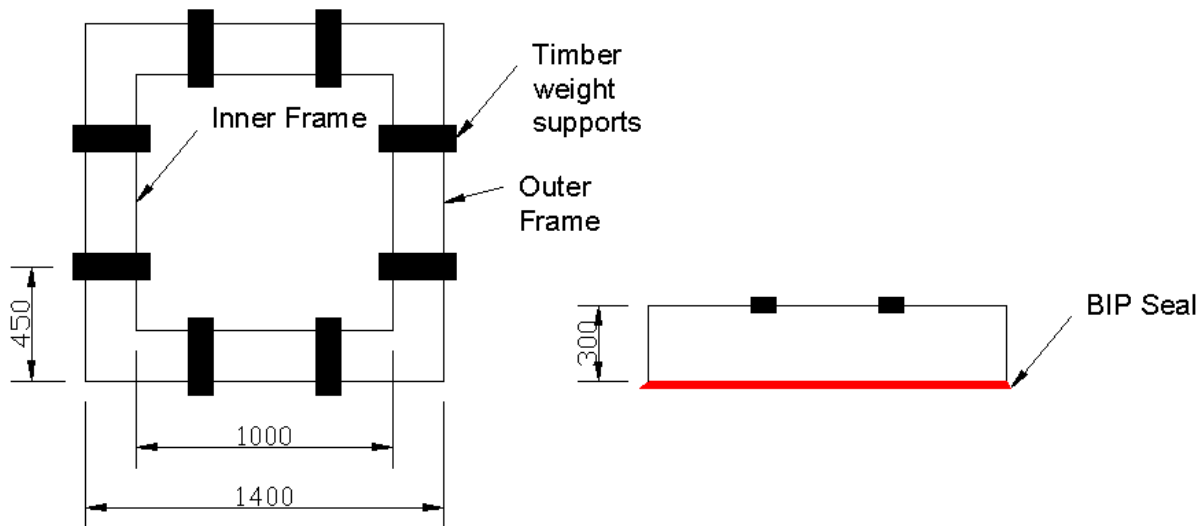
Infiltration measurements were made using a double-ring infiltrometer. The equipment is shown in Figure 1. The inner and outer sections were made square with hinged corners. The inner section was 1m x 1m square so that a much larger area of paving was sampled in each test than has been common in previously reported infiltration tests conducted on PICP. The perimeter edges of the in-

Figure 1. Double Ring Infiltrometer (all dimensions in mm).
