WORKING WITH REGULATORS TO CHANGE PERMEABLE PAVEMENT ACCEPTANCE

Hunt, III, William F.

William F. Hunt, Biological and Agricultural Engineering, NC State University (NC SU), Box 7625,
Raleigh, NC, 27965-7625, USA. Tel.: +1-919-5156751, Fax.: +1-919-5156772.
bill_hunt@ncsu.edu

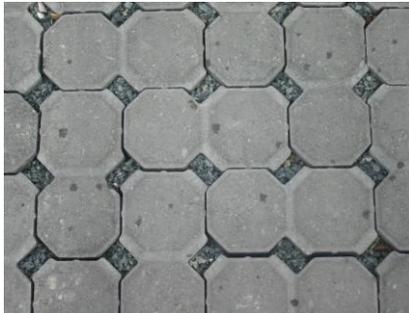
Figure 1a. PICP

Figures 1a, 1b, and 1c show three of the most common permeable pavements: concrete grid pavers (CGP), permeable interlocking concrete pavers (PICP), and permeable concrete (PC). CGP have

both internal voids and voids between individual pavers. PICP are concrete pavers that when installed form voids located at the corners and midpoints of pavers. PC is different from standard concrete in that fine aggregate has been removed from the mix, allowing interconnected void spaces to form during curing. Permeable pavements allow drainage through the existence or formation of these void spaces.

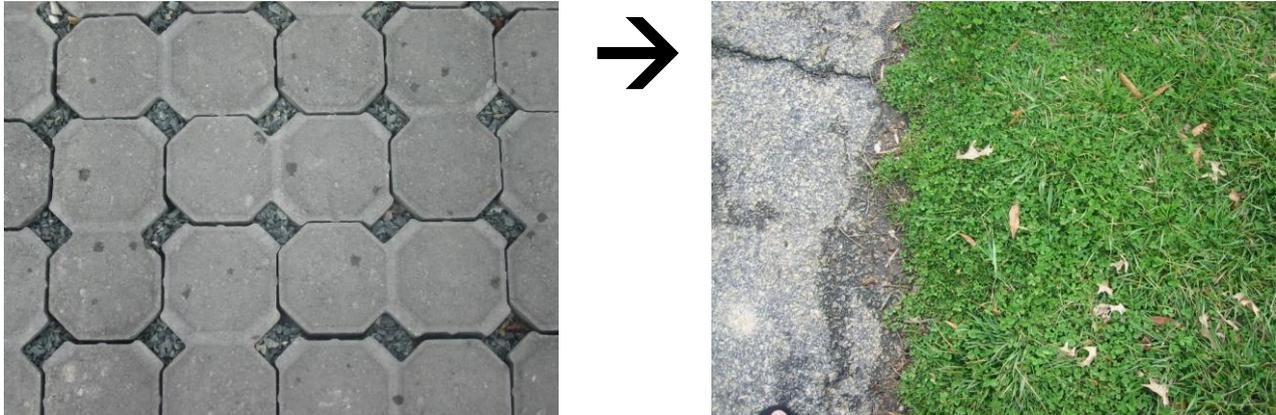
SCS Curve Number equation. In addition, an equivalent ratio of grassed area (CN: 61) to pavement area (CN: 98) based on runoff depth for each event (> 50 mm) was calculated (see Figure 2).

Figure 2. Ratio of grassed area to impervious pavement area hydrologically equivalent to permeable pavement.

Three permeable pavement sites across eastern North Carolina (located in Kinston, Wilmington, and Swansboro) were instrumented to determine runoff reduction performance. For each site, rainfall was measured onsite and runoff was routed over a weir for flow-rate measurement. The Kinston site was constructed of CGP filled with sand. The pavers were laid on 50 mm of bedding sand over a permeable geo-textile to prevent clogging of the storage basin (200 mm of washed No. 57 stone) below. The Wilmington site was constructed with 100 mm of permeable concrete (enough to store 25 mm of runoff) laid over top of a sandy base soil, with no gravel storage layer. The Swansboro monitoring site, which contained a 300 mm gravel base, was a PICP lot filled with pea gravel. For ease in regulatory understanding of the data, NC State researchers compared hydrologic performance of each system to a hybrid system of impermeable pavement and grass lawn. Each permeable system's performance could be related as a composite of some ratio of impermeable pavement to grass (see Figure 2).
